Newar urban settlements: the evolution of Newar seismic engineering solutions?

An Occasional Paper from The Bhanimandal Evening Earthquake Seminars, Kathmandu, May 2015

by James Goodman with Meryl Dowman

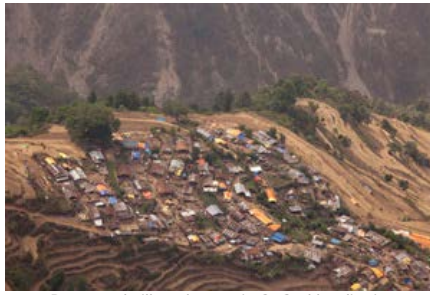
Destroyed village homes in S. Gorkha district

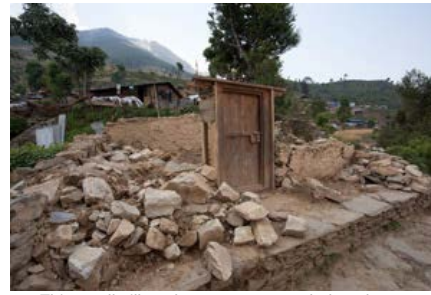
This small village home was a stand-alone house

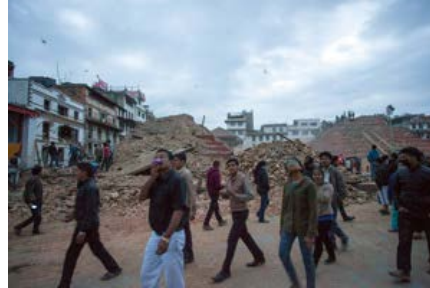
Kathmanduites walk dazed among the collapsed stand-alone temples

The stand-alone temple structures in the Kathmandu Valley suffered considerable if not catastrophic damage:

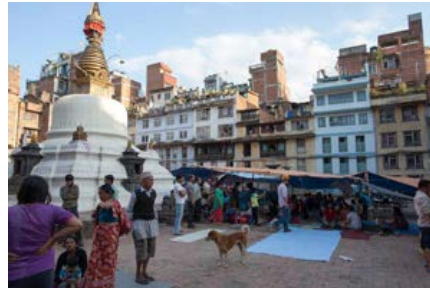
People sleeping outside their homes

However the historic densely packed high-rise tenement style urban settlements of the Kathmandu Valley were generally relatively unscathed. Note how modern reinforced concrete technology provokes and allows increasingly taller elements in the structures. The tall stand-alone structures standing proud of the general level of surrounding buildings seen behind the stupa below would not be possible with simple masonry structures:

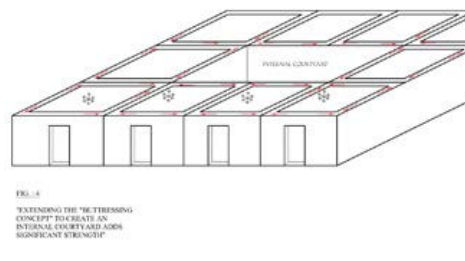
Fig. 4

FIG. 4
"EXTENDING THE 'BUTTRESSING CONCEPT' TO CREATE AN INTERNAL COURTYARD ADDS SIGNIFICANT STRENGTH"

Crucially, adding rooms on one, two or three sides of the original room allows the additional rooms to buttress the original room (see Fig. 3), and of course vice versa. Hence in the absence of the ring beam concept, the addition of rooms either side of the original room provides a solution to the lack of structural resistance in walls that are not tied. Admittedly, this solution is not as robust as a ring beam, which secures all four outer walls, but it is nonetheless a dramatic improvement on a stand-alone structure. This may also help explain why the construction of buildings around a square originated, as it avoids having a vulnerable last wall. (See Fig. 3 and Fig 4).

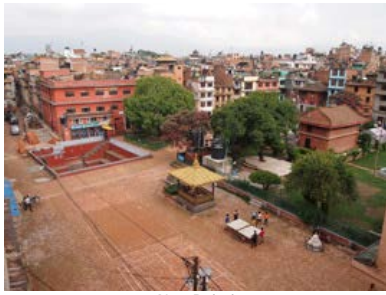
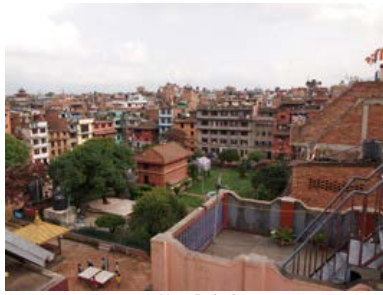
If one accepts that this technique of building in densely packed settlements, and small squares in particular, provides added structural reinforcement, it is then a small step to large squares, such as Nag Bahal in Lalitpur (see photos below) and to some of the exquisite *sattals* of the historic Newar settlements. Moreover, we begin to understand the use of small squares as reinforcing structures in the corners of larger squares (akin to buttressing). In sum, this paper postulates that given the greatly reduced risk from earthquakes, Newars increasingly moved from stand-alone, single-storey structures to houses that were joined together in ever increasing complexity such that stand-alone, single family buildings evolved into one large structure comprising many family units.

It goes without saying that contemporary seismic engineering techniques may be useful to complement traditional Newar design in some instances (note the new, reinforced concrete frame structures in the Bahal photographs); introducing modern techniques is just another evolutionary step. However, these are extraordinary structures which have evolved over time specifically in response to an ever present hazard. They have survived relatively well and, with active maintenance, should survive long into the future.
